MEMORANDUM

DATE:	October 31 st , 2016
FROM:	Eric Lancaster
SUBJECT:	Weekly Progress Report @ Gold King
TO:	Kerry Guy

Project: Gold King Interim Water Treatment Plant (IWTP)

Report No.: 42

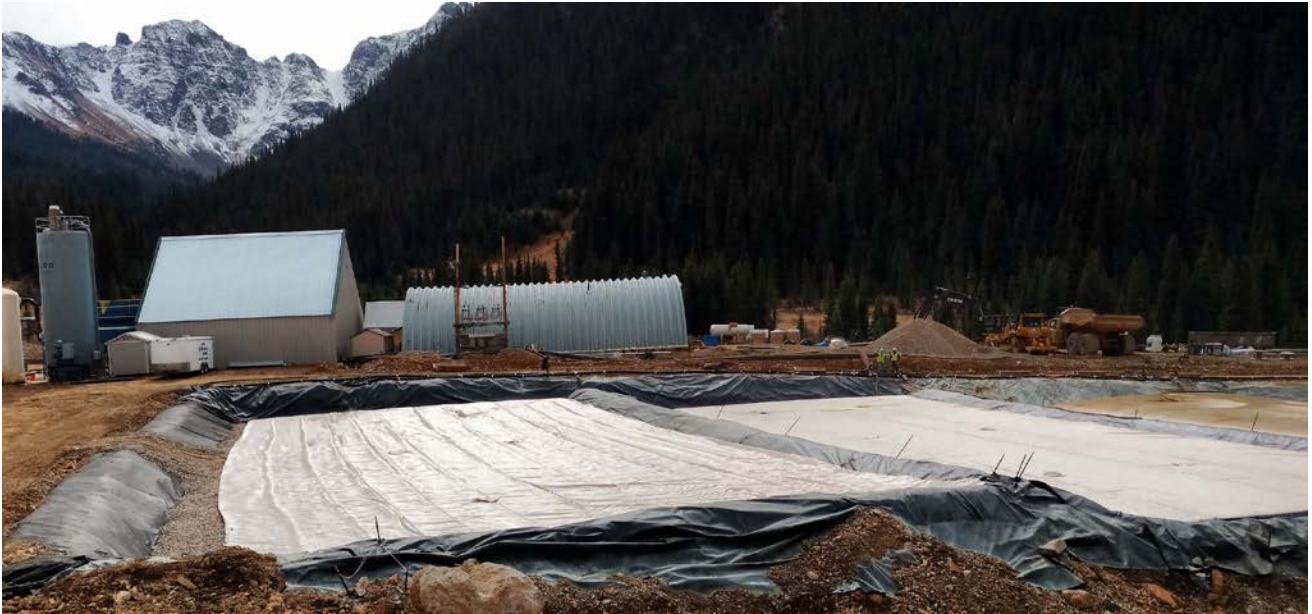
Photo 1: View of Cell A on 10/28 from County Rd 110.

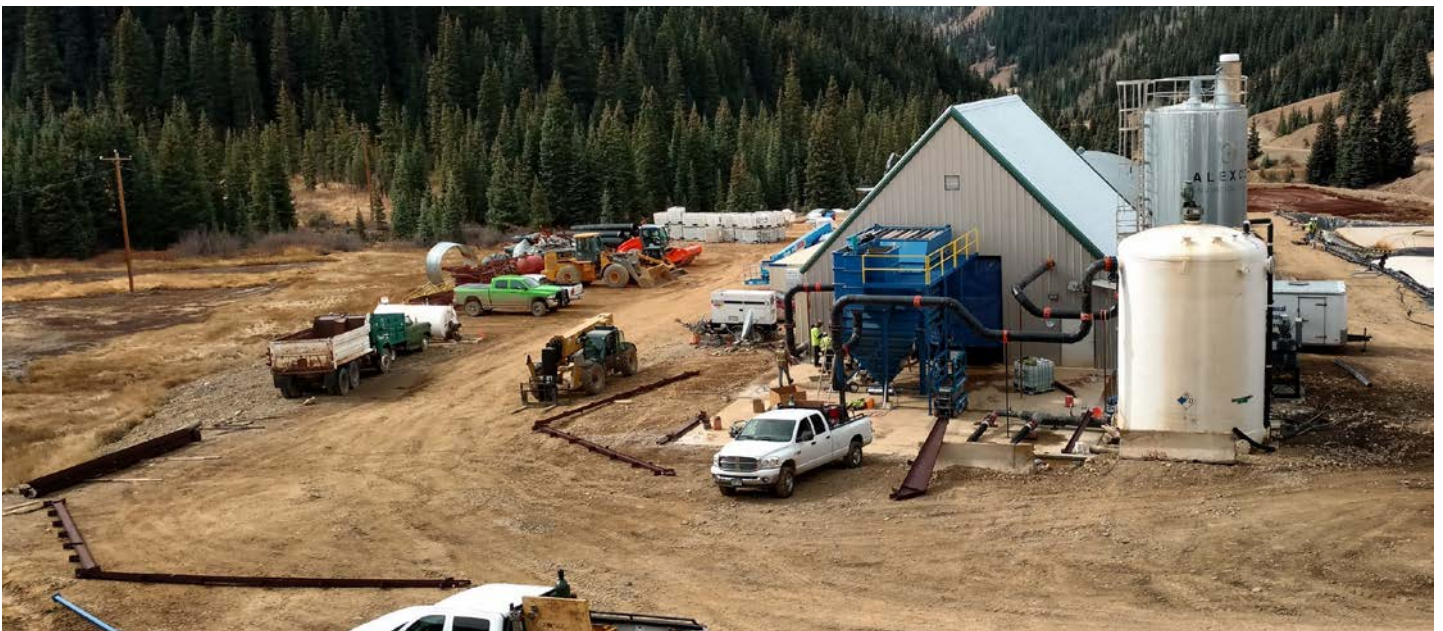
Photo 2: Taken on 10/28, this photo shows the preparation for installing steel supports (red iron). Notice that the 12' x 14' door was removed and the Phase II clarifier catwalk installed.
